LESSONS FROM SEISMIC ASSESSMENT IN WELLINGTON REGION

BUILDING A BETTER NEW ZEALAND
2014 CONFERENCE

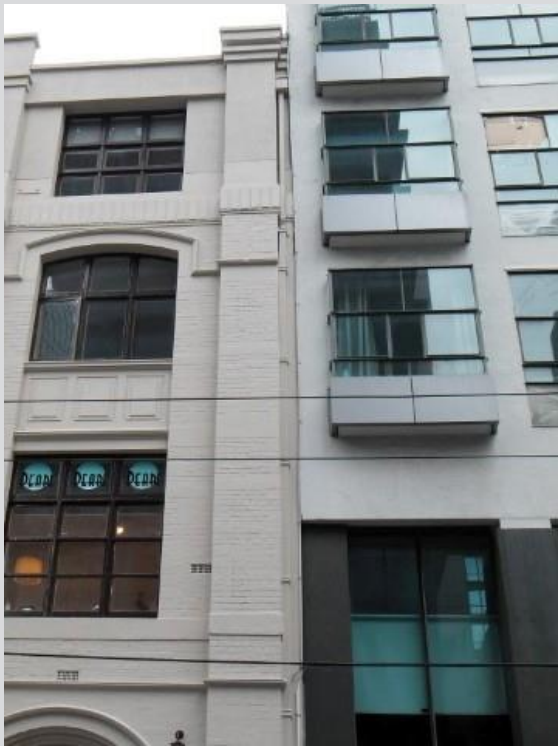
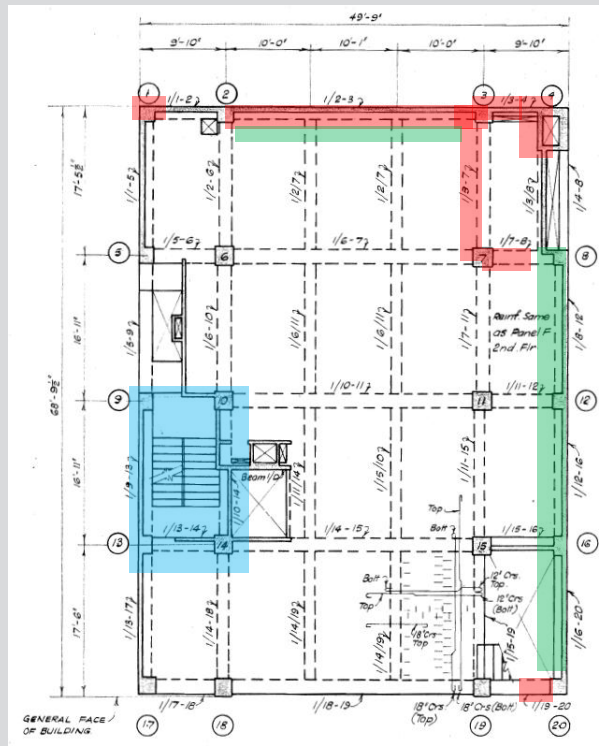
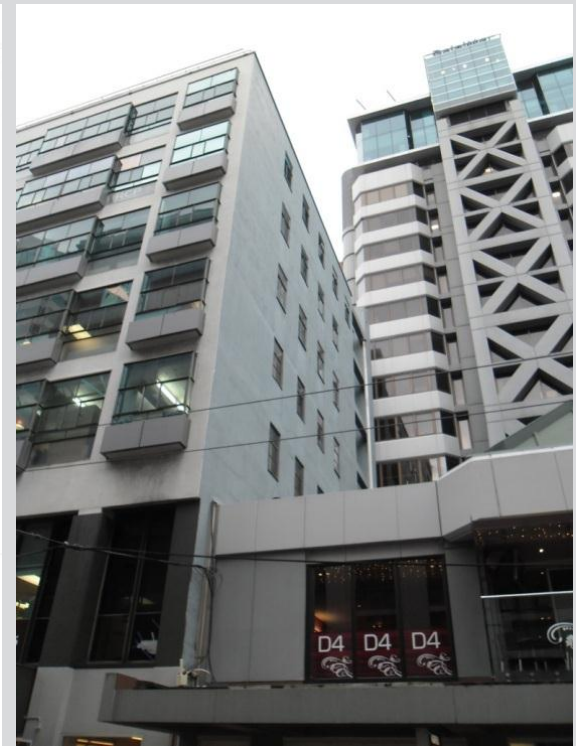
critical components
-

area of cracks-1
-

area of cracks-2

CONCLUSION: the critical components (desktop study) \neq the area of cracks (site investigation)

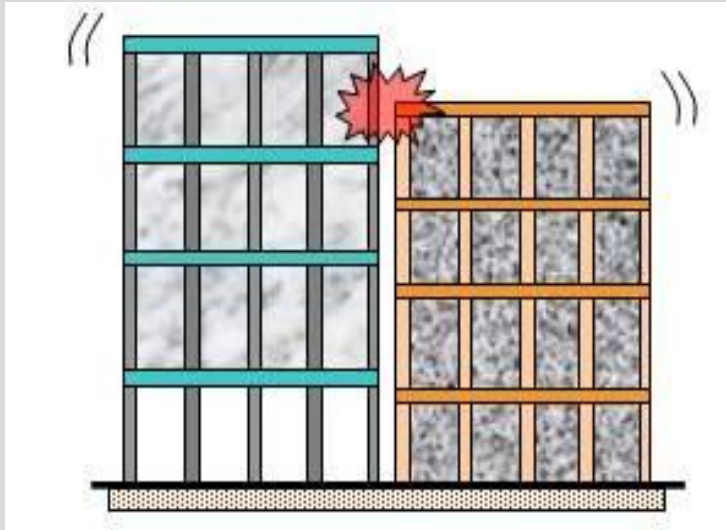
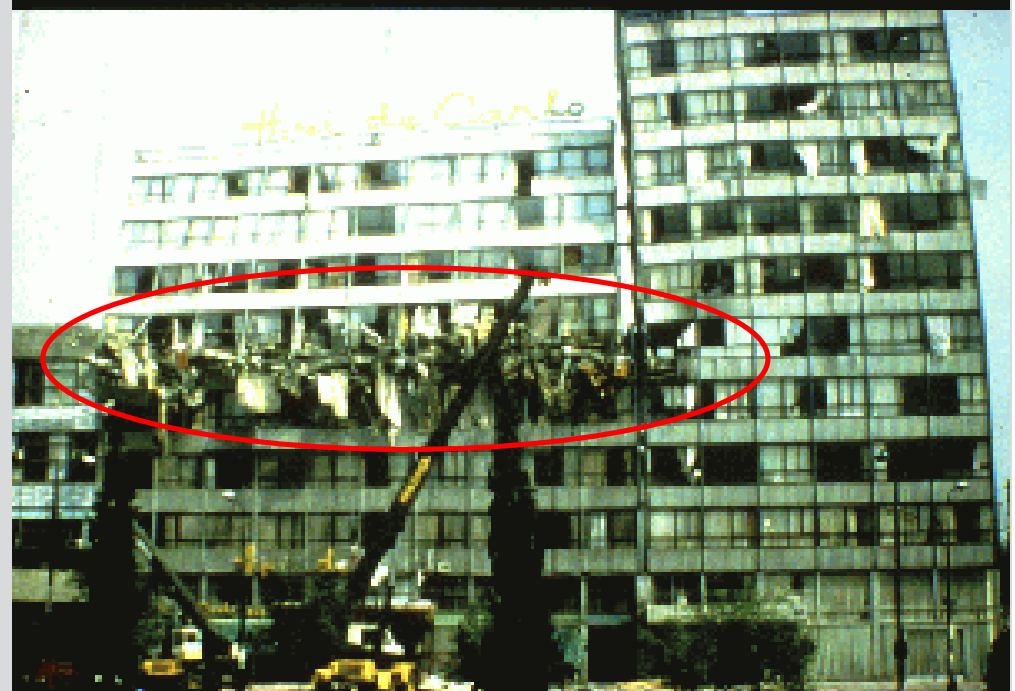
Pounding: impact between buildings during earthquakes

Mid-floor failure of a hotel caused by pounding after the Mexico earthquake in 1985

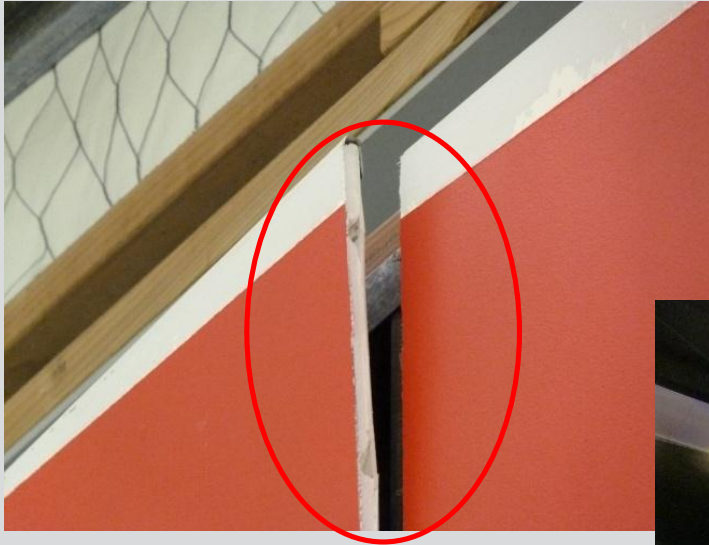
Gib-board clad partition walls were separated from the steel frame

Lack of integration between structural and non-structural elements

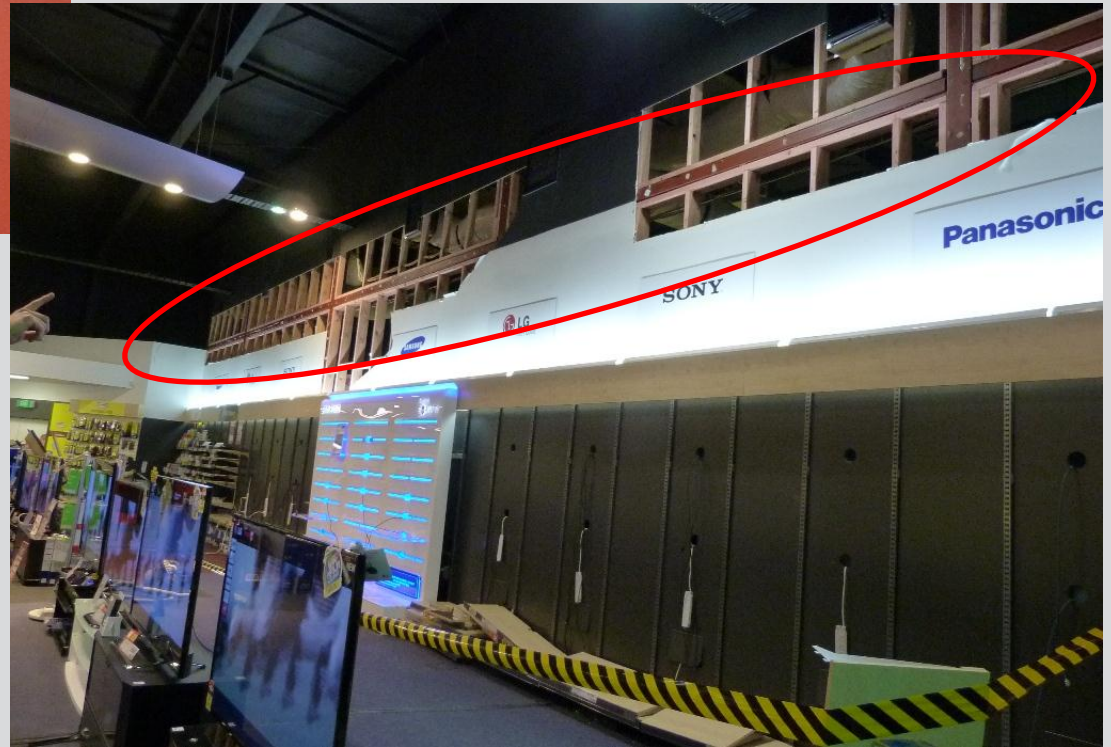
Gib-board failure along the secondary timber framed partition wall

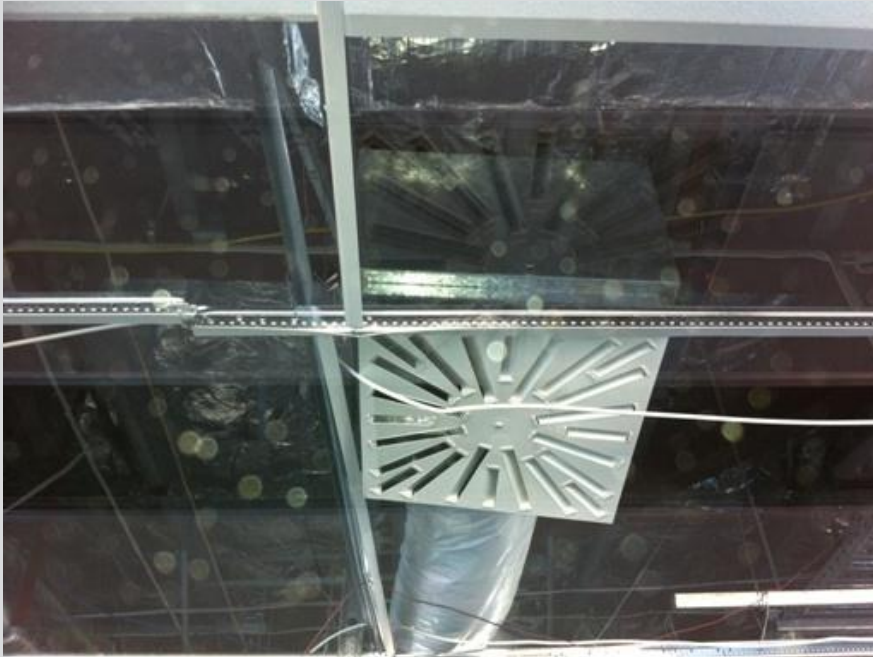
Ceiling failure in a new-built building

Lack of integration between structural and non-structural elements

RECOMMENDATION:

More extensive effort to achieve structural performance of:

- Main structure and Non-structural components
- Integration of the non-structural members and the main structure (detailing)
