# Condensation in Large-Cavity, Steel-Framed Roof Spaces: Causes and Cures

Malcolm Cunningham, Luca Quaglia, Stephan Rupp, BRANZ

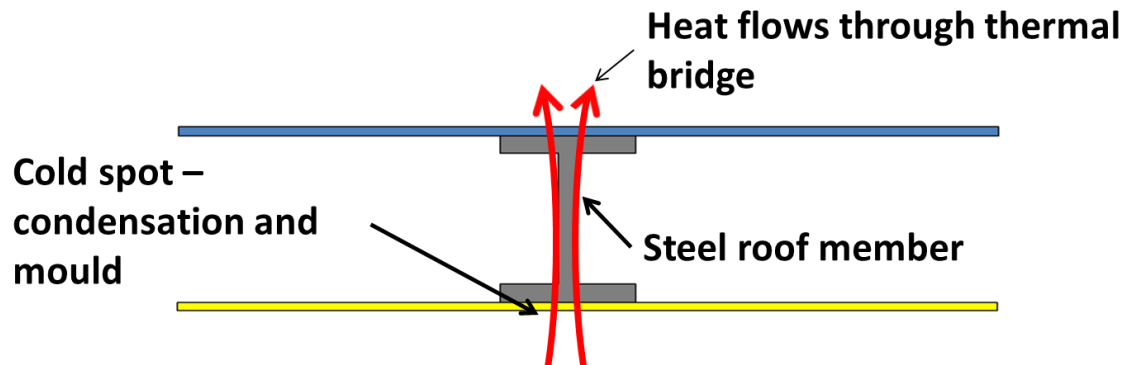
**Defining feature: roof and ceiling connected by high conductive path**

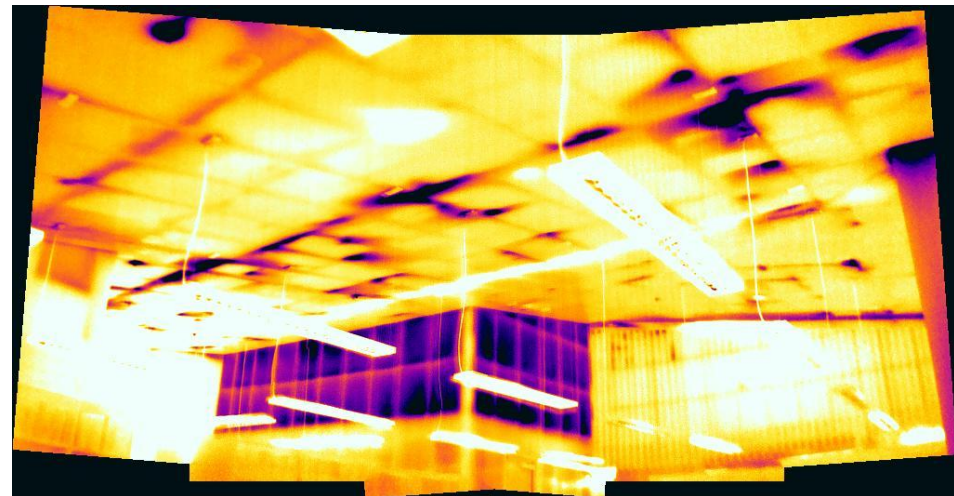
**Defining symptom: patterned lining mould growth**

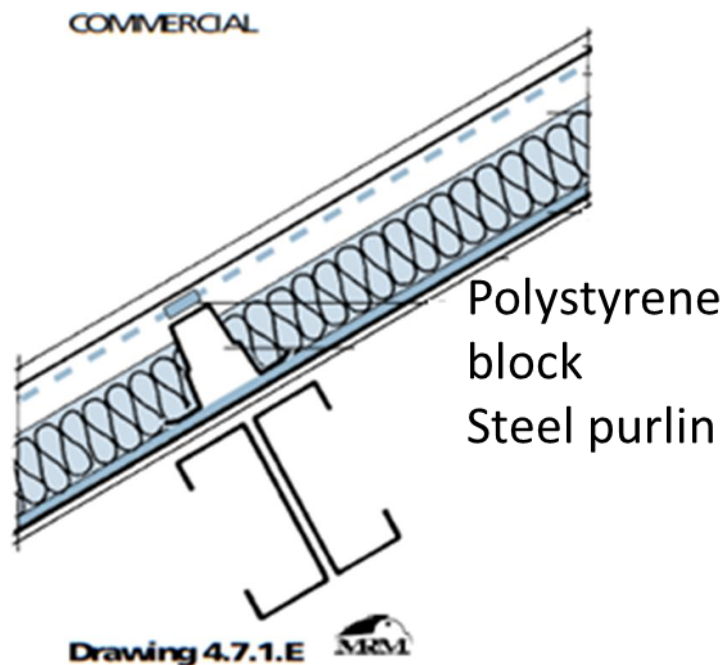
- d) Where steel studs are used, a thermal break shall be provided for each steel member. Wood fibre insulating board or expanded polystyrene (EPS) strips, 12 mm minimum thick and fixed directly behind the external cladding provide an effective thermal break.

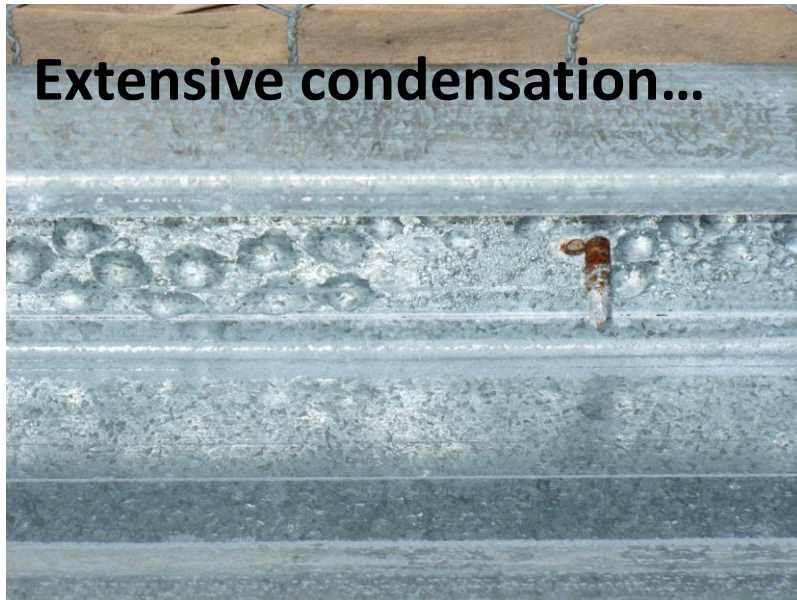
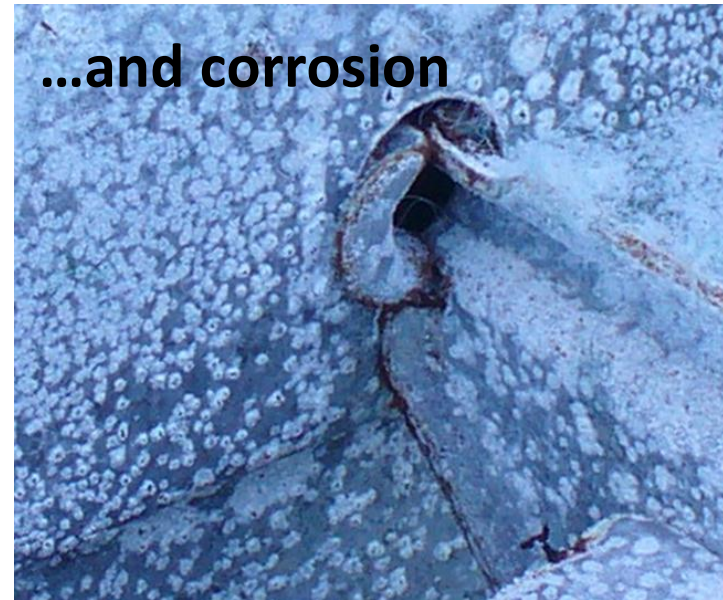
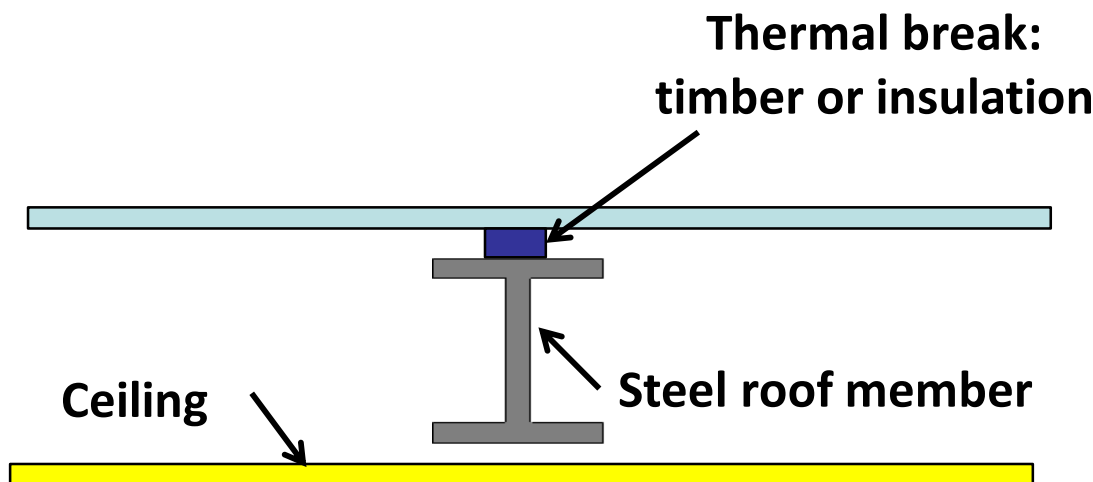
# Aggravated Thermal Bridging

**For aggravated bridging,  
timber isn't always  
enough**

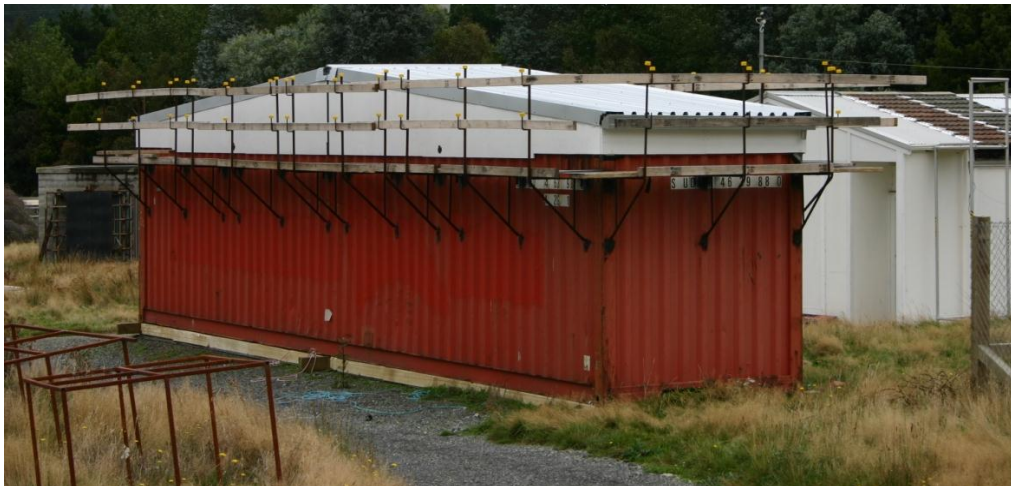
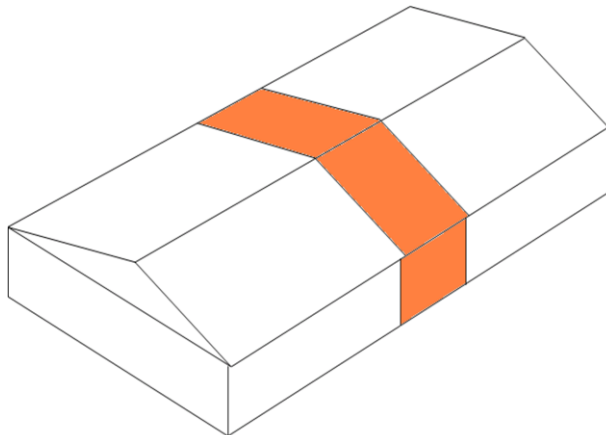
Roof Test Rig Container with 4 different roofs trialled:

- Transportable (different climate zones)
- Full control of indoor climate (temperature and humidity)
- Extensive sensing & data acquisition

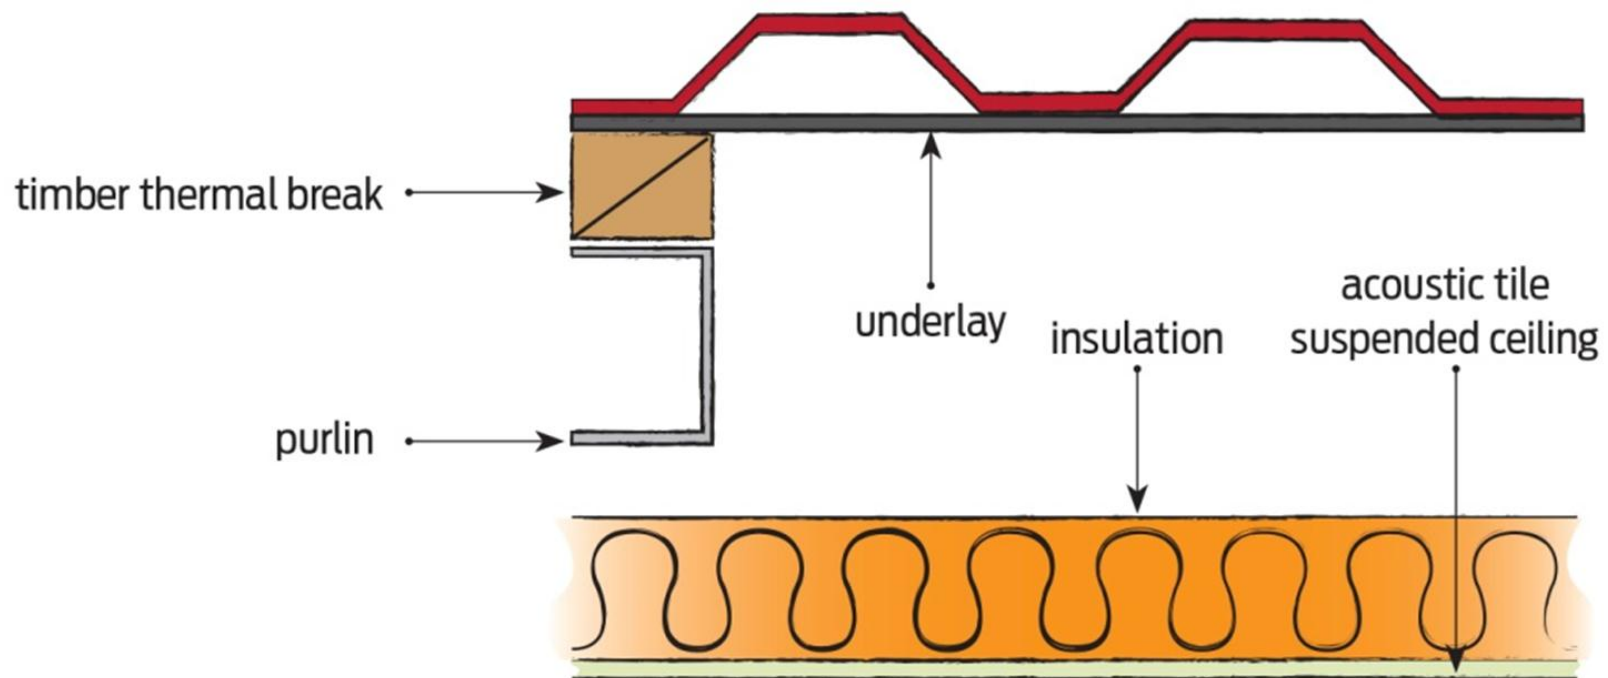
# Specimen 1: Timber Thermal Break

## Reference Case

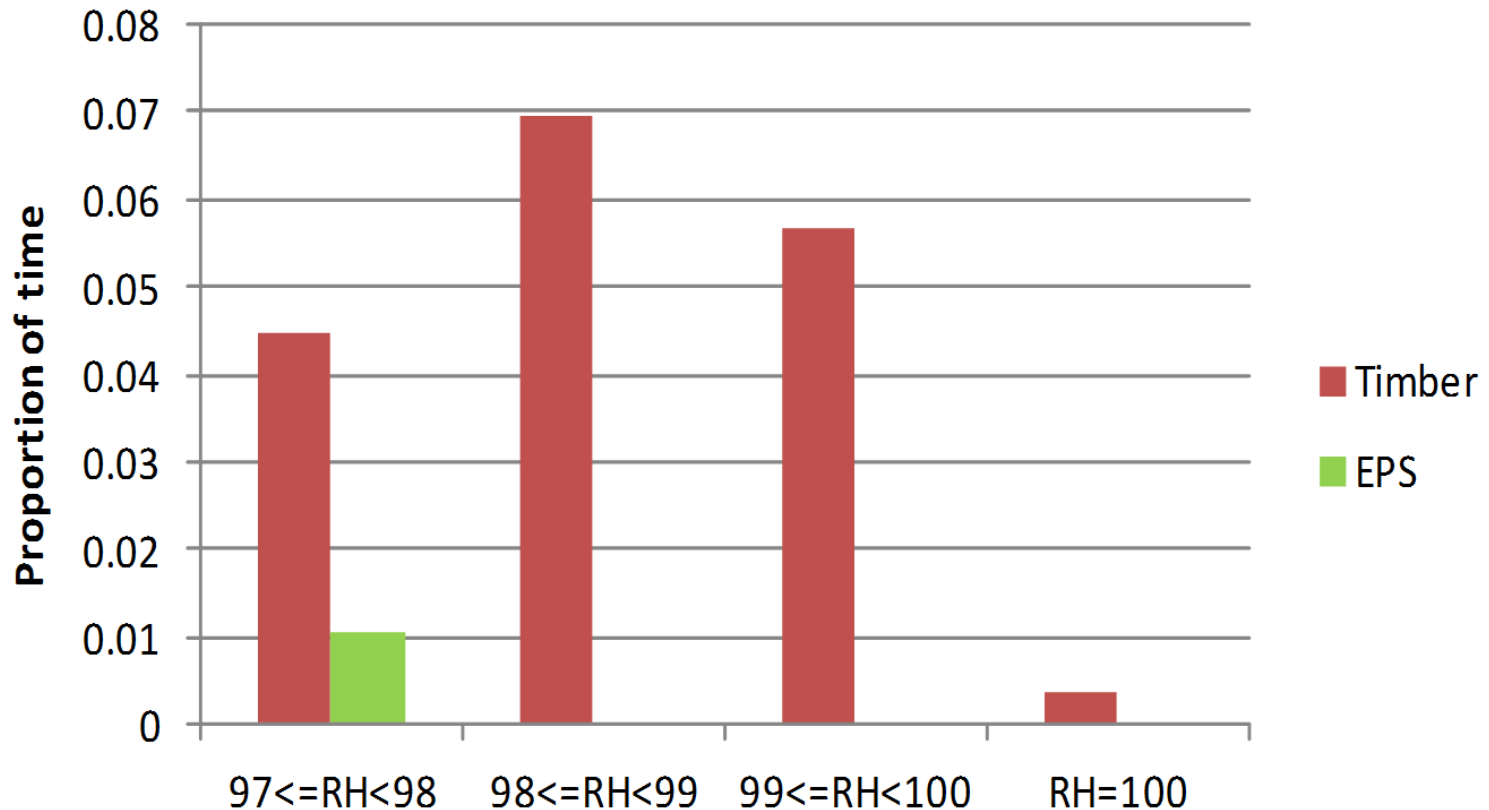
# Results: Relative Humidity

**By metal purlin. Proportion of time at high relative humidities**

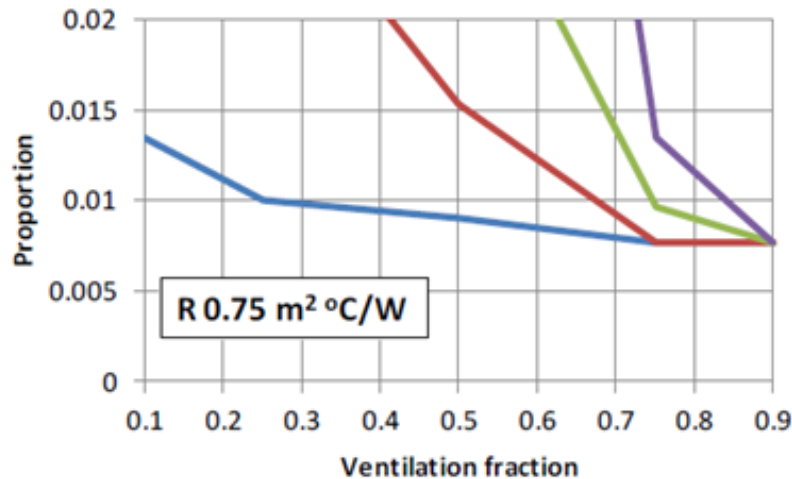
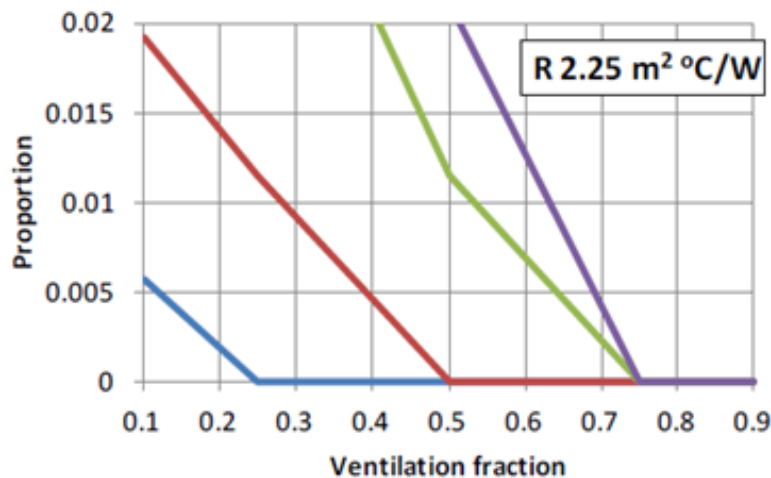
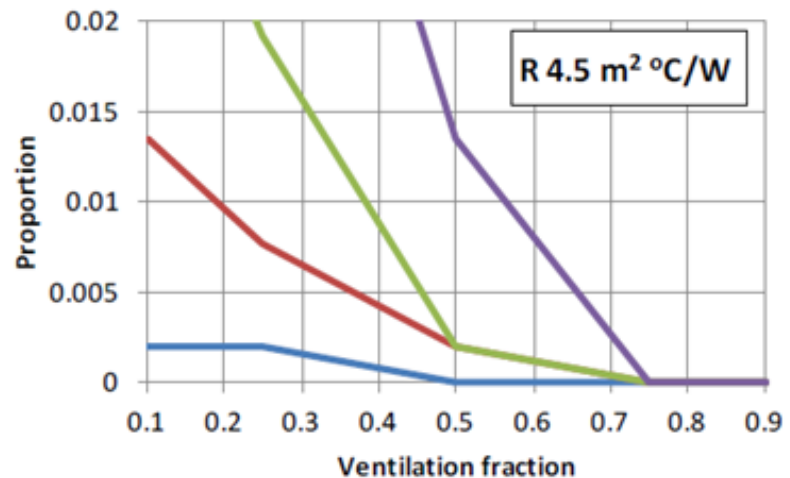
## Proportion of time cavity greater than 98% RH

### Indoor climate

- Dry
- Moderate
- Wet
- Very wet

- R-values for insulation above cavity
- Ventilation Fraction: Ratio of outdoor to indoor ventilation rates

- ▶ **Full-width board insulation can fix aggravated thermal bridging problems**
- ▶ **Preliminary findings:**
  - ▶ **R-value  $\geq 2.25 \text{ m}^2 \text{ }^\circ\text{C/W}$**
  - ▶ **Ventilation fraction of 0.75 or higher**
- ▶ **EPS system: relatively cheap, no structural loadings, needs to meet fire regulations**

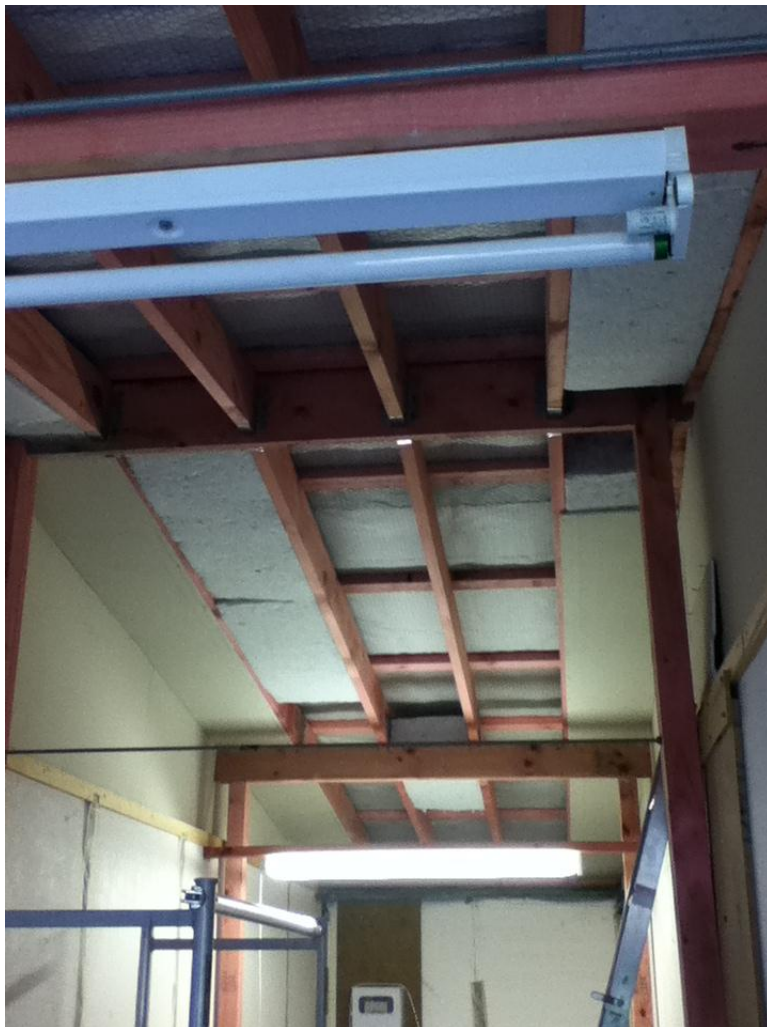
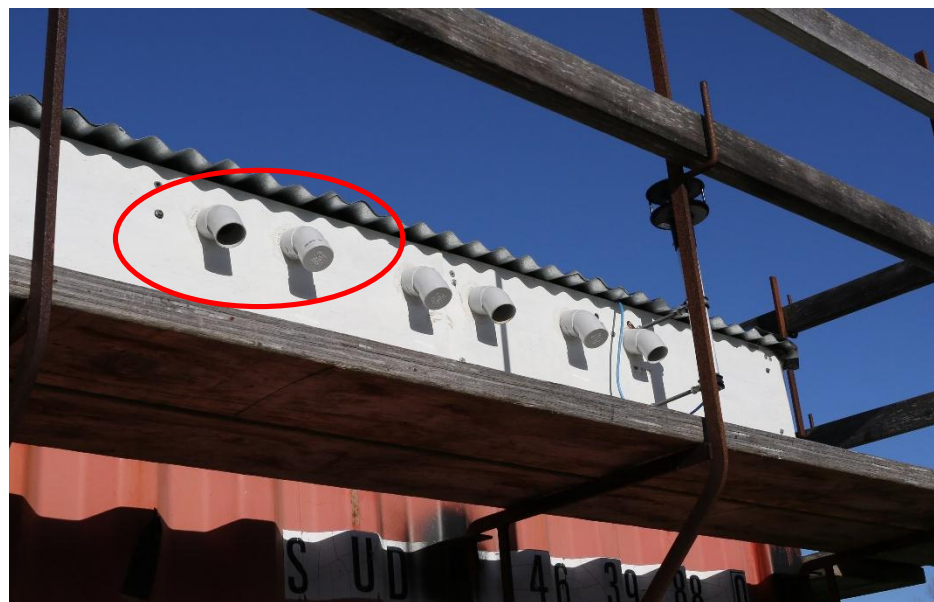
View into Roof Testing Rig with Skillion-Type roof

Level of roof cavity ventilation can be varied

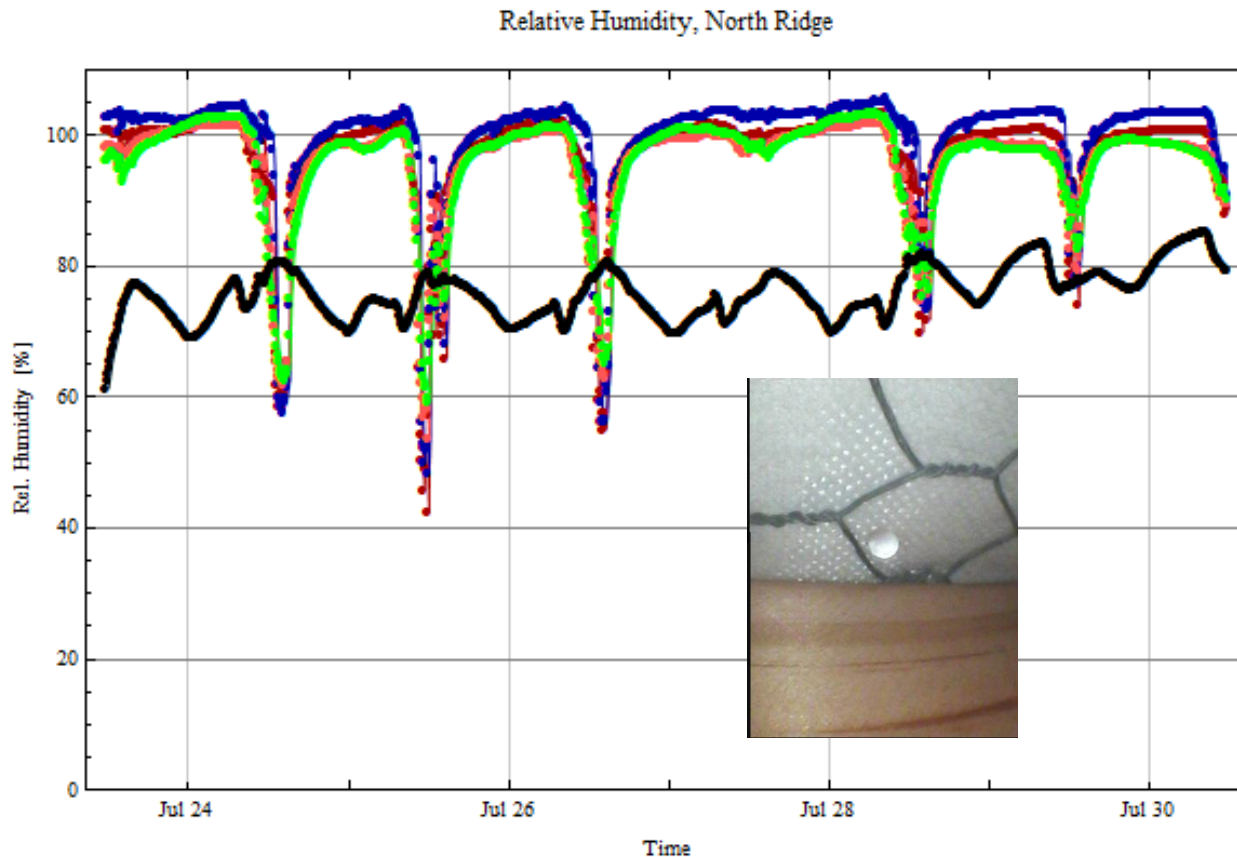
Humidity Sensors across roof and ceiling, measurements taken over a cold week without minimal ventilation: extended periods of 100 % Rel. Humidity with some visible condensation on the underlay
